# **A320 SLAT GRA ATA 27**

**RTW 2023**

**Liebherr - Aerospace**

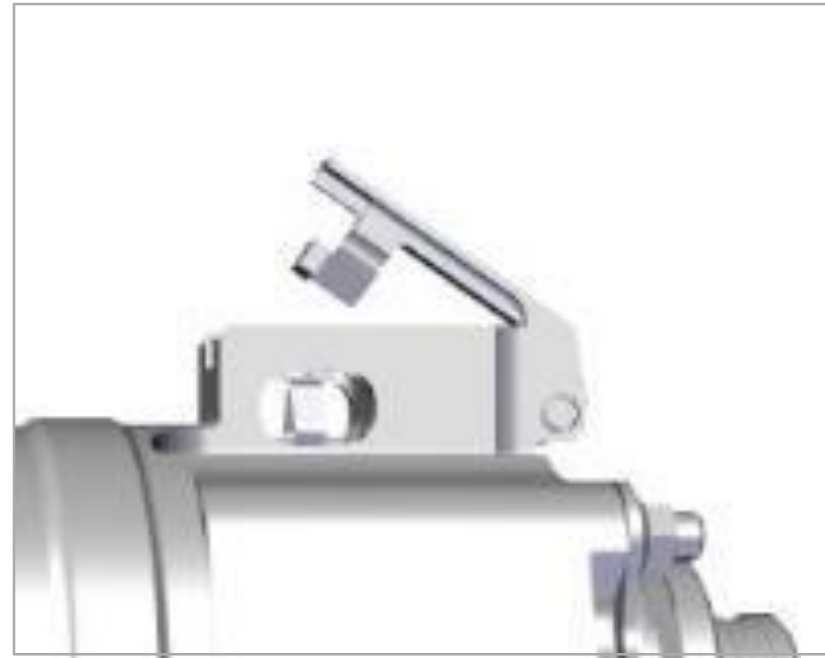
## SLAT JAM

LOCKOUT INDICATOR ACTIVATED  
MOSTLY ON A321 TRACKS 9, 10, 11:

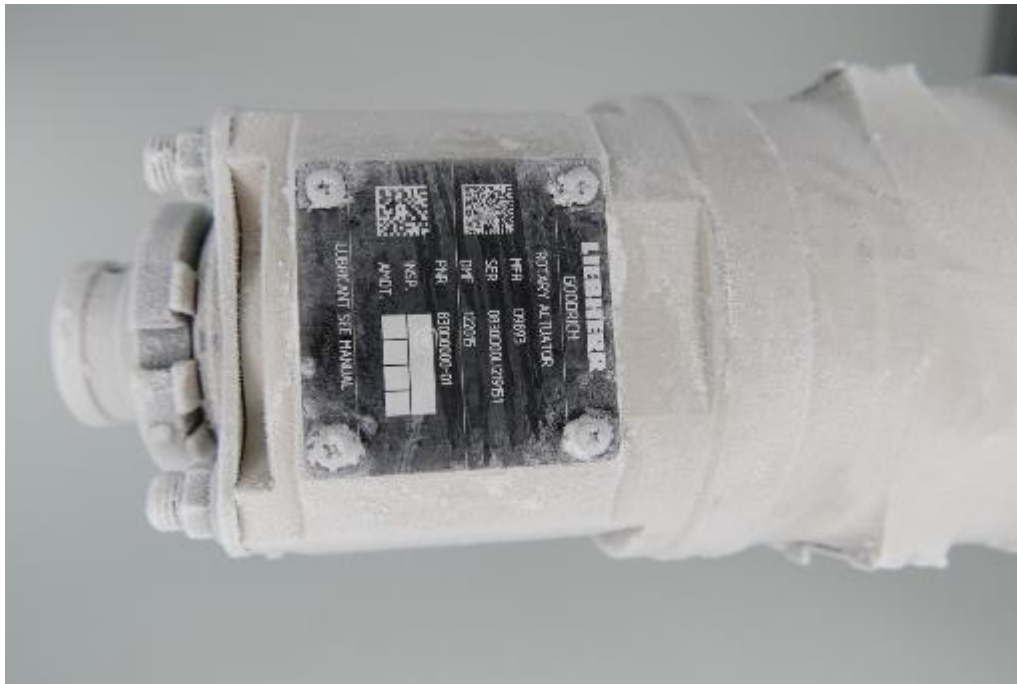
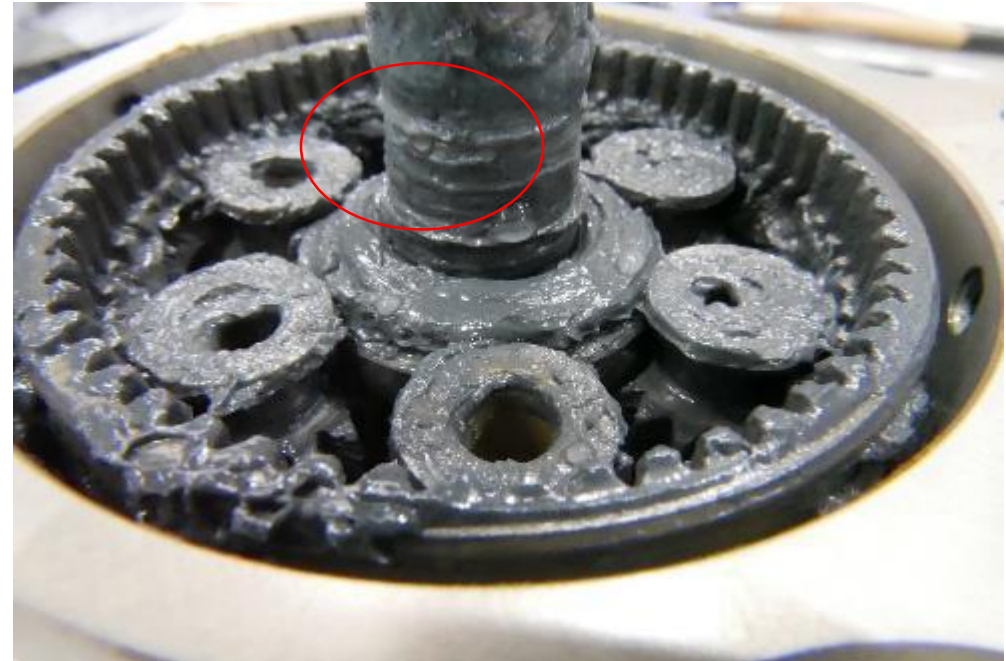
- 43% of returned GRAs jammed @ -40°C test \*
- Moisture found on 45% GRAs during disassembly.\*

\*: data based on returned GRAs due to slat jam (total units:55)

- Recommendation: ship affected units in sealed plastic bags to avoid water evaporation
- Reminder: Report every slat jam event to Airbus

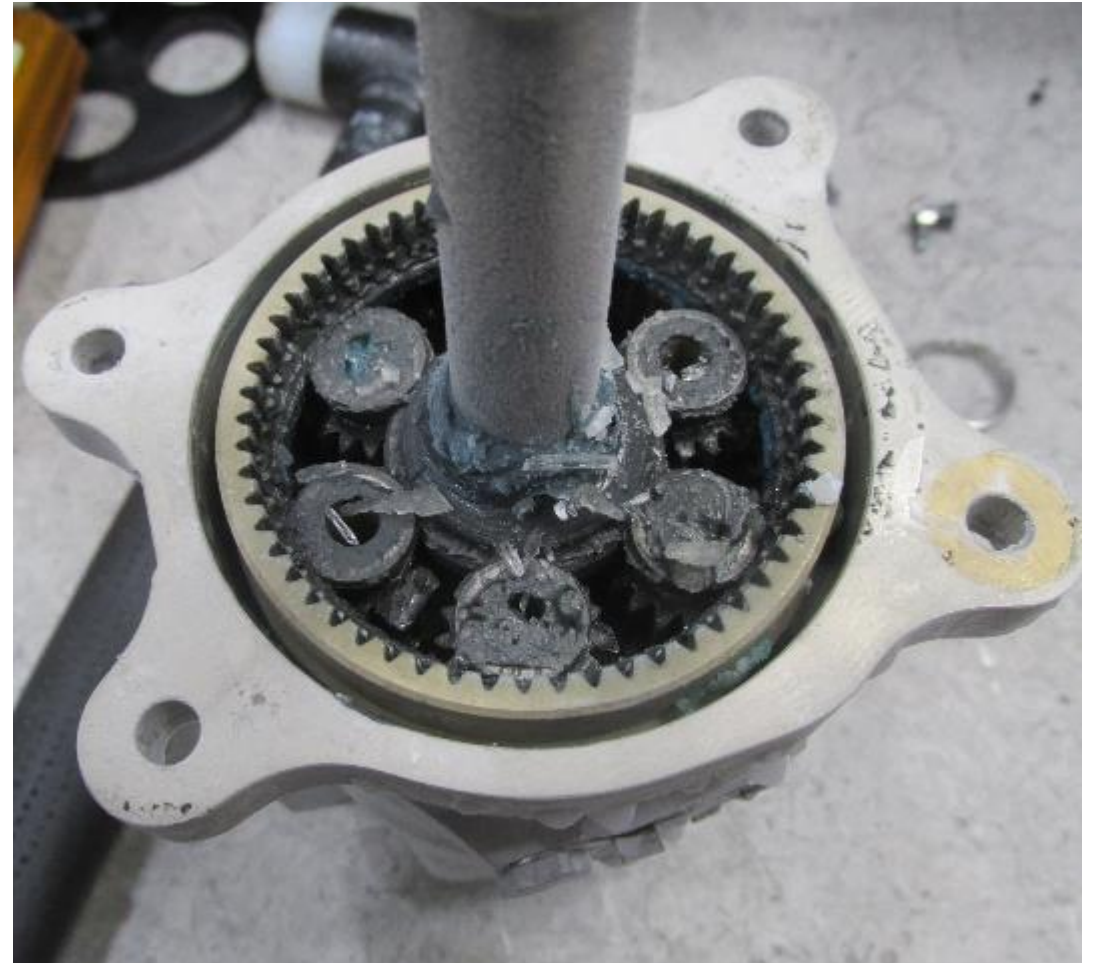
- Root cause on GRA level: Frozen water
- Root Cause contributor on A/C level: Increased wing bending (sharklets) - Refer to Airbus TFU 27.80.00023 for more information
