A330 APPU ATA 27

RTW 2023

APPU – Ratcheting: Recap

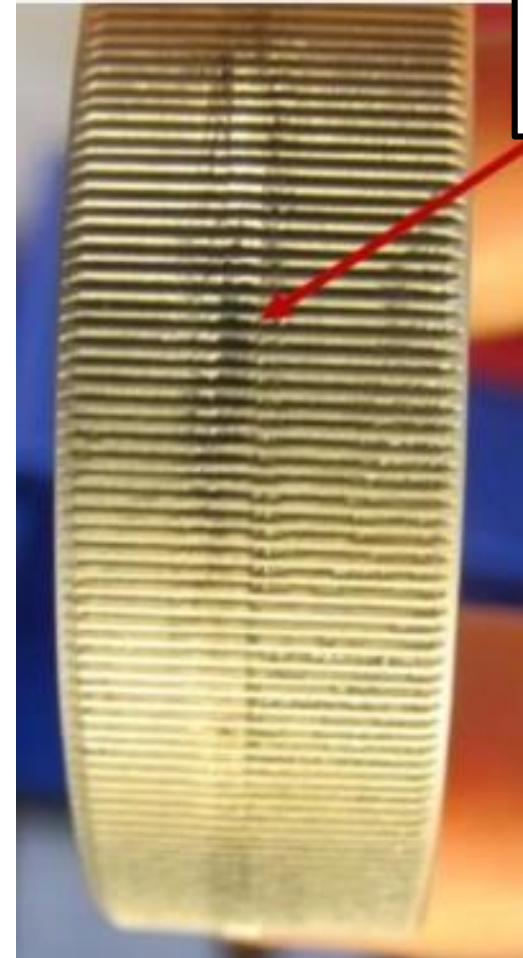
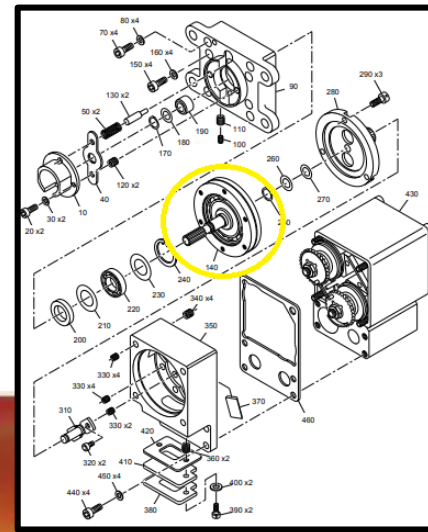
- Flaps locked during approach on A/C delivered since DEC 2016
- ECAM warning F/CTL FLAPS LOCKED
- Root Cause:
 - Seal of (black anodized) connector insufficient
 - Low temp conditions: moisture inside harmonic drive freezes → ratcheting
 - Ratcheting causes offset between electrical vs. mechanical position → asymmetry
