A330 APPU ATA 27

RTW 2023

APPU – Ratcheting: Recap

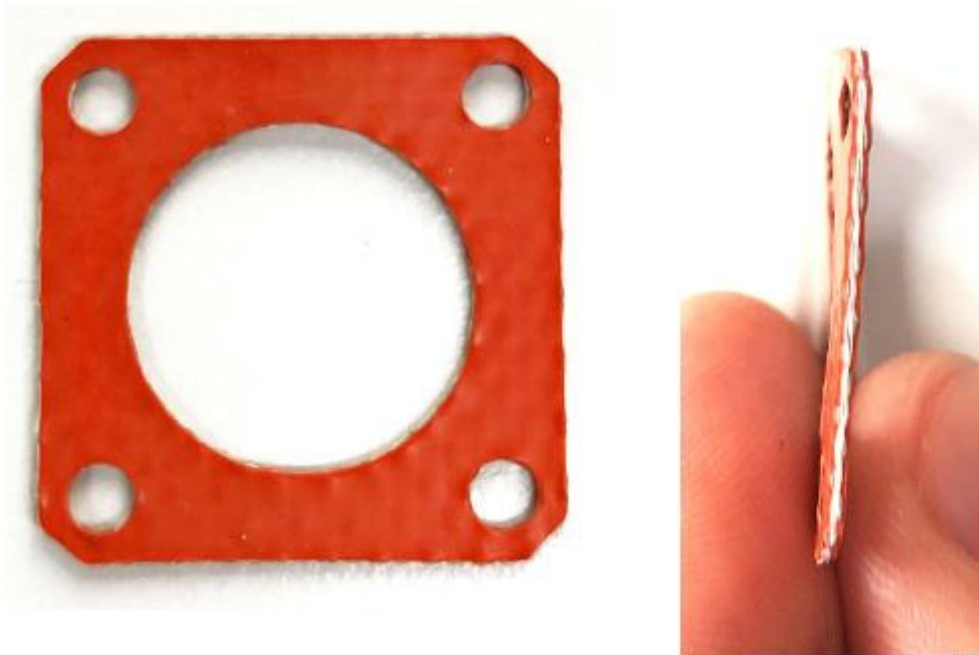
- Flaps locked during approach on A/C delivered since DEC 2016
- ECAM warning F/CTL FLAPS LOCKED
- Root Cause:
 - Seal of (black anodized) connector insufficient
 - Low temp conditions: moisture inside harmonic drive freezes → ratcheting
 - Ratcheting causes offset between electrical vs. mechanical position → asymmetry

➤ Back to the roots!
